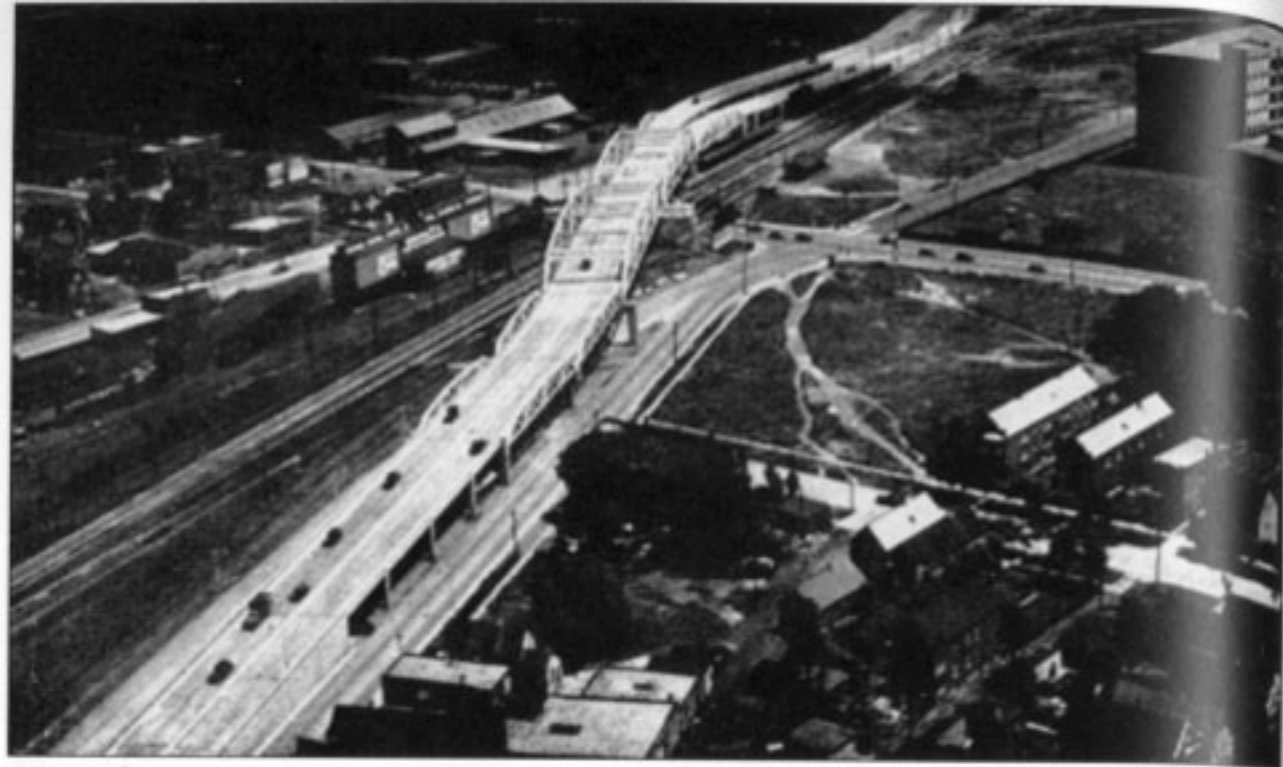
As cars flooded Chicago's streets, safe rail crossings became a critical problem. Near the Chicago border with the town of Cicero, Ogden Avenue (Route 66) shared a four-lane subway under the Chicago, Burlington and Quincy Railroad with the traffic from two other streets. Each day, 31,000 vehicles squeezed into the passage, creating a near-constant bottleneck. According to the *Chicago Tribune*, the Illinois Division of Highways completed the viaduct in 1939, shown here, which they called their "most complicated grade separation problem ever tackled." The view above looks northeast toward Chicago; the view below shows an Ogden Avenue streetcar heading west into Cicero via a tunnel beneath the viaduct. The viaduct was a quarter-mile in length, and the roadway on the truss bridge was 45 feet above Cicero Avenue, the north-south cross street below. (Below, photograph by Truman Hefner, courtesy of the Krambles-Peterson Archive.)

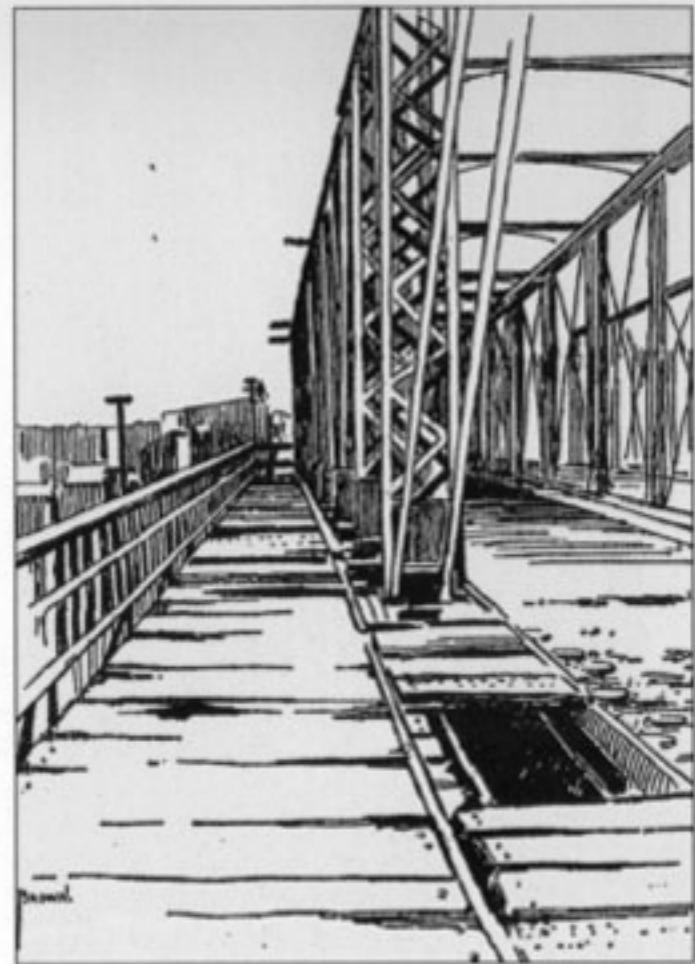
Starting in the 1840s, railroads built their tracks approaching the city's periphery at grade level. As Chicago grew, the grid of city streets engulfed the tracks with no separation between urban neighborhoods and high-volume rail traffic. Five rail companies used the right-of-way across Ogden Avenue between Western Avenue and Rockwell Street, including the Chicago and North Western Railroad. A 700-foot-long viaduct carried Ogden Avenue over the tracks in 1892, but it was in severe disrepair by 1900, as shown in the *Chicago Tribune* illustration at right. In December 1900, a woman named Tillie Canniff fell through a hole in the wooden sidewalk to her death on the tracks below. The railroads made repairs, but by 1910, a new steel and concrete structure (below) elevated the tracks above grade.
